# COLD STORAGE WAREHOUSE FIRE: LEARNING FROM WORCESTER

BY TIMOTHY J. KEARNEY

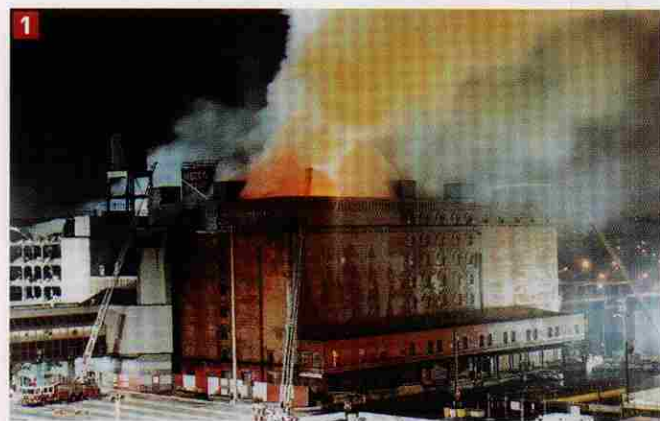
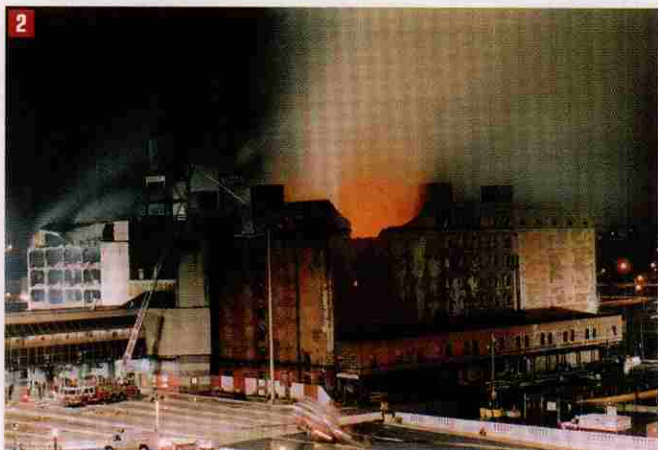
(1, 2) Apparatus use the entrance to the Holland Tunnel, which connects New Jersey to New York City, to put master streams in operation. Units operated at this location for 13 days, keeping the tunnel closed to all traffic for one week. (Photos by Mike McNamara.)

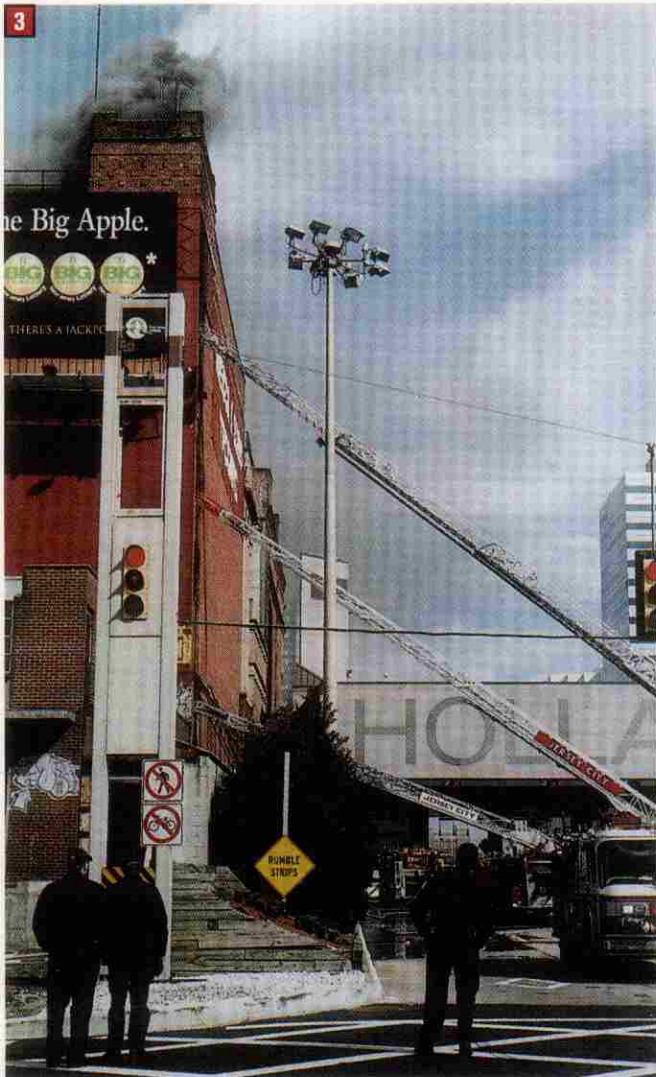
(3) Responders removed two civilians by aerial ladder.

Firefighters using an aerial ladder removed the victim through the window, along with a second victim who was overcome and lying on the stairwell floor below the window. The window was approximately 24 inches wide by 48 inches high. It consisted of two units set in steel frames mullioned together. The victims were pulled through a 24- by 24-inch opening, the size of one sash. Firefighters could not break through the steel frame with the hand tools they had with them at the time.

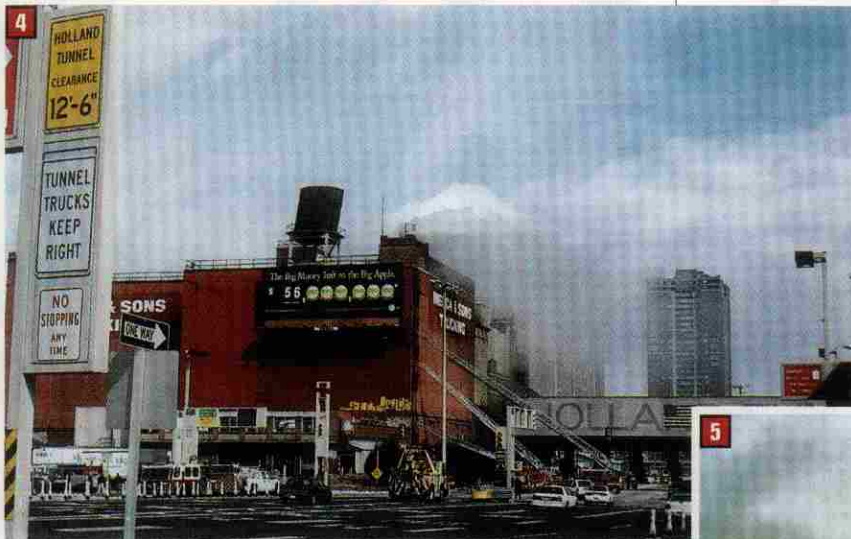
(4) Smoke is showing from stairwells at each corner of the building. Note the leaning water tower on top of the building. (5) Large cracks in the west wall show the heavy fire inside and helped lead to the IC's decision to withdraw personnel from the building.

Primary searches were conducted at all locations accessible to firefighters (search areas were large, open spaces typical of warehouses; dangers such as unprotected openings in floors, open elevator shafts, and lack of means to ventilate the building rendered some locations inaccessible). Thermal imaging cameras were used to scan the open floor areas for victims and to monitor crews as they searched and fought the fire. After the searches were concluded, the IC decided to withdraw all units from the building permanently. Also, the scene safety officer reported to the IC that the building was starting to develop a large crack down the west wall.
